Ninney Rise House

405 Alexander Drive, Bingil Bay

Heritage Colour Study

Prepared for Friends of Ninney Rise
December 2020
Final Report

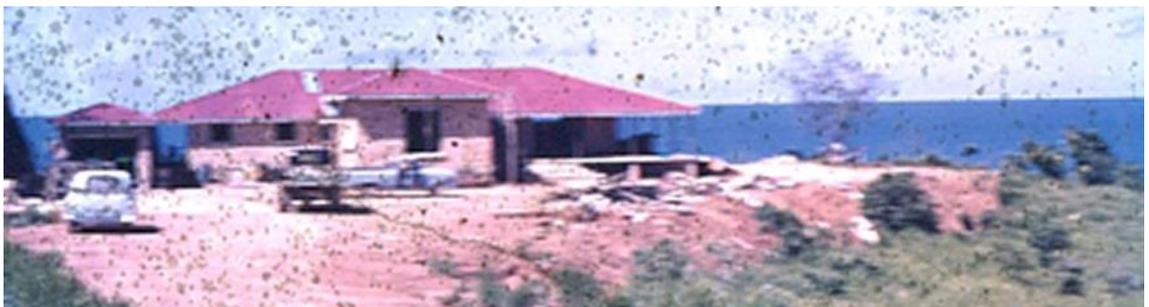
Figure 1: Early photo of Ninney Rise residence nearing completion c. 1960 (VEC)

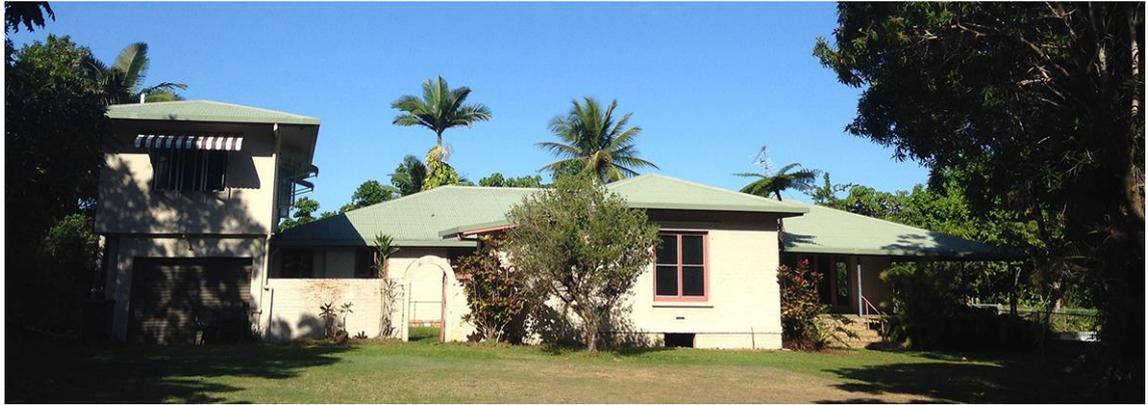
Figure 2: Ninney Rise viewed from West in 2017. The upper level extension (left) and the bathroom extension (centre behind the small tree) were excluded from this colour study.

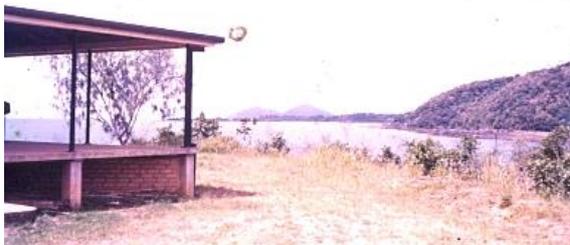
SW corner – dark blue posts, brick under unfinished

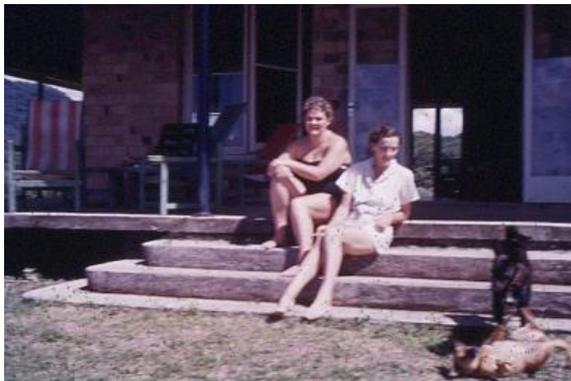
Zara Holt and Alison Büss on east steps. Slab appears slightly red/pink. Posts are blue but doors and windows still white on outside.

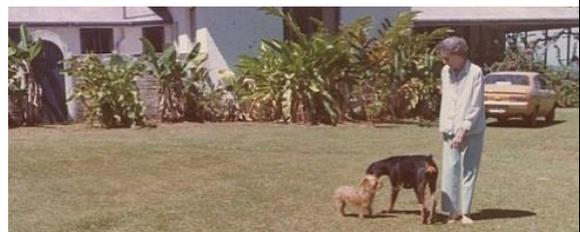
West elevation - overgrown foreground and umbrella tree gone. Whitewash faded/stained. Roof light coloured (lighter than other colour photo?)

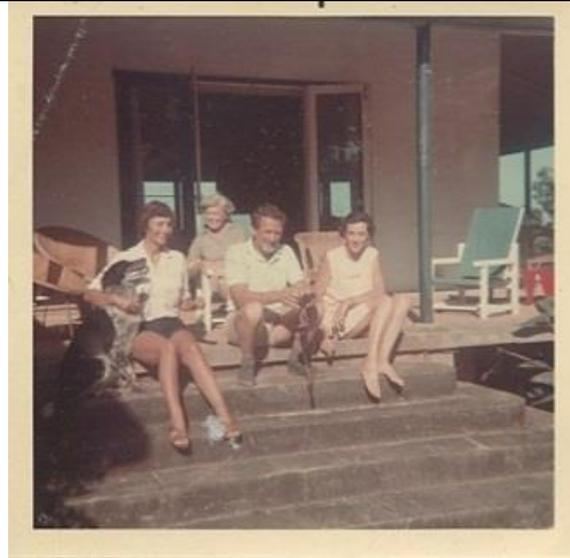
Blue posts and door exteriors, white washed walls and tinted concrete (soil-stained?) verandah floor. Zara Holt at rear, Alison Búst on right.

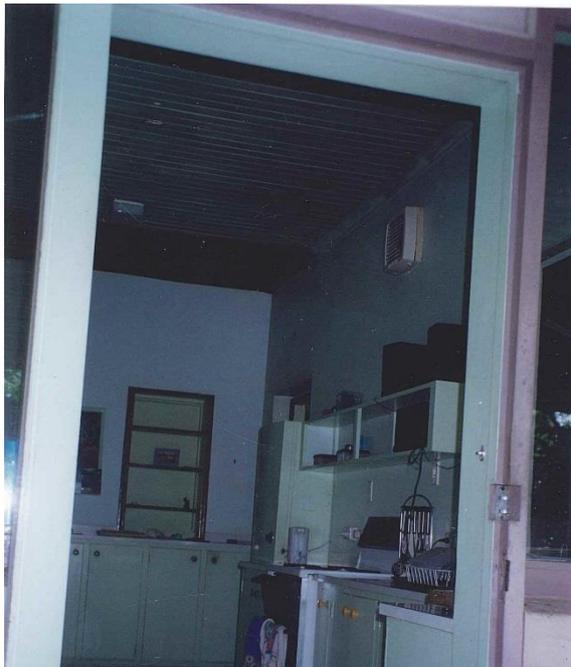
Kitchen doorway – Pinky brown door frame, light door interior, pinky off-white brickwork, lighter panel over door. (QPWS)

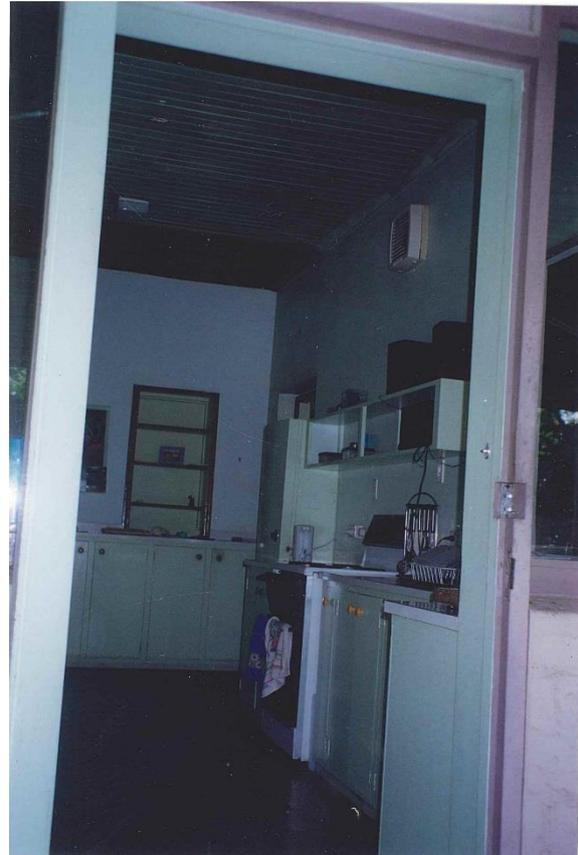
Ceiling – Darker colour but vj grooves in ceiling boards and cornice show lighter. Could be deep apricot colour found in paint layers.

Kitchen doorway – Pinky brown door frame, light door interior, pinky off-white brickwork, lighter panel over door. Deep ceiling colour. (QPWS?)

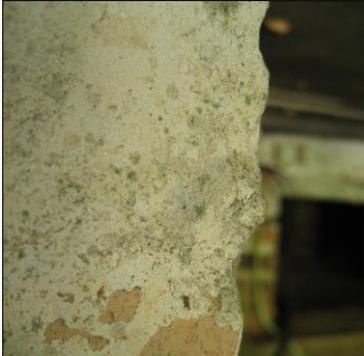
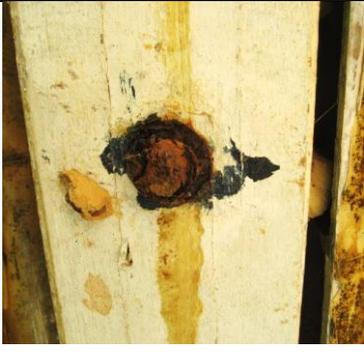
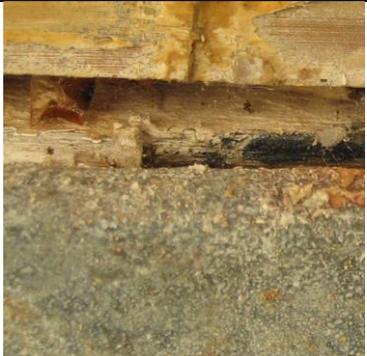
Table 3. – External colour samples - typical

<p>Brickwork limewash - subfloor</p>	<p>Verandah beam east – dark blue and line of clear between former bamboo trimming</p>	<p>Remnant of dark blue overbrushing (behind new steel verandah post top plate) from original steel post.</p>

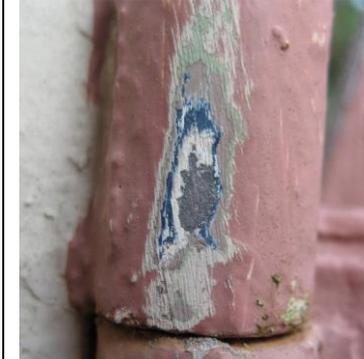
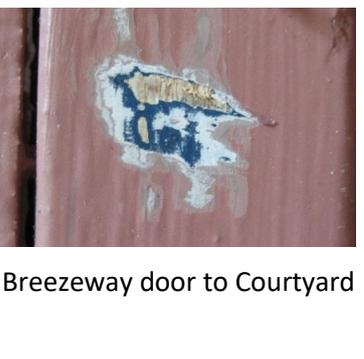
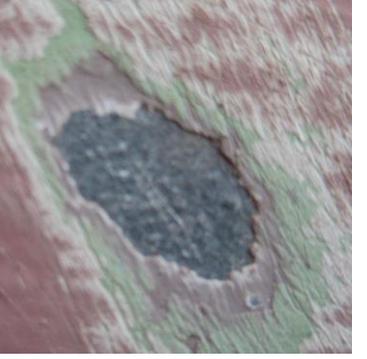
<p>Courtyard gate - hinge</p>	<p>Breezeway door to Courtyard</p>	<p>Tode era handrail to steps</p>

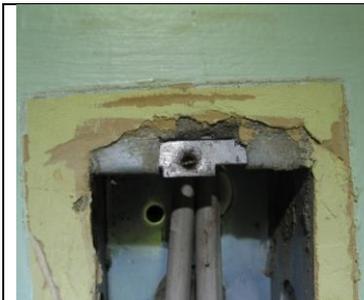
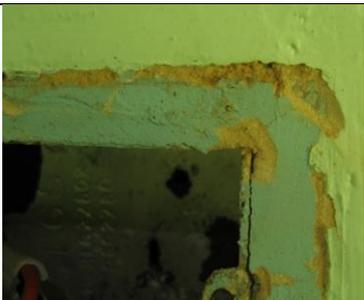
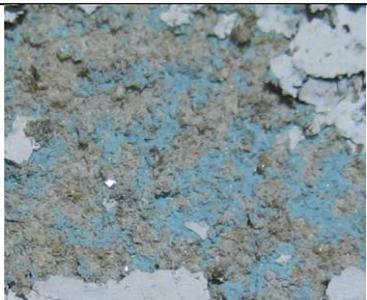
Table 4. – Internal colour samples

<p>Bedroom 2 wall behind light switch</p>	<p>Living N wall behind cover plate</p>	<p>Kitchen Hall – back of Kitchen cabinet</p>

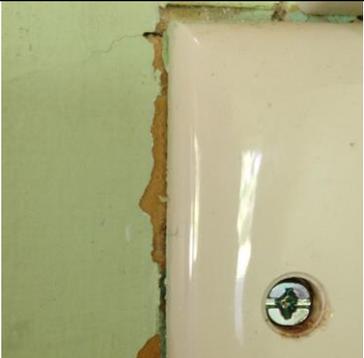
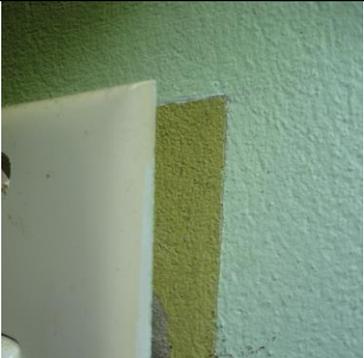
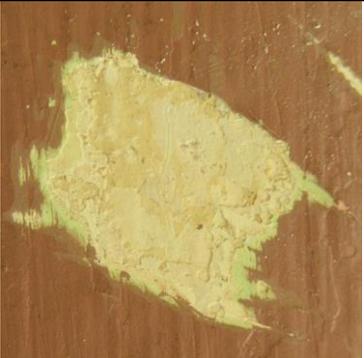
Living wall (W) showing ochre and blue	Side Hall yellow	Typical window interior

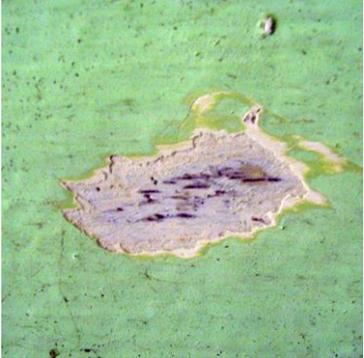
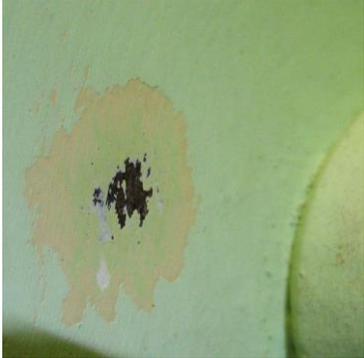
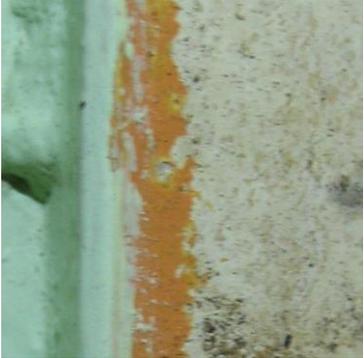
Kitchen cabinets	Dressing Room cupboard door	Bedroom 2 door jamb (under missing bamboo to jamb)

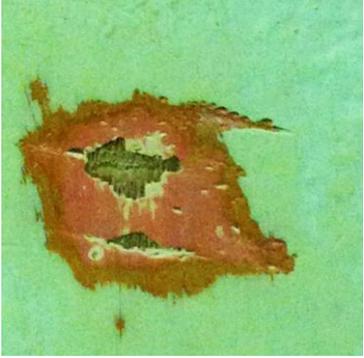
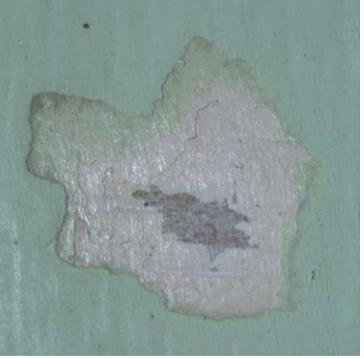
Door to Bedroom 1	Bathroom architrave

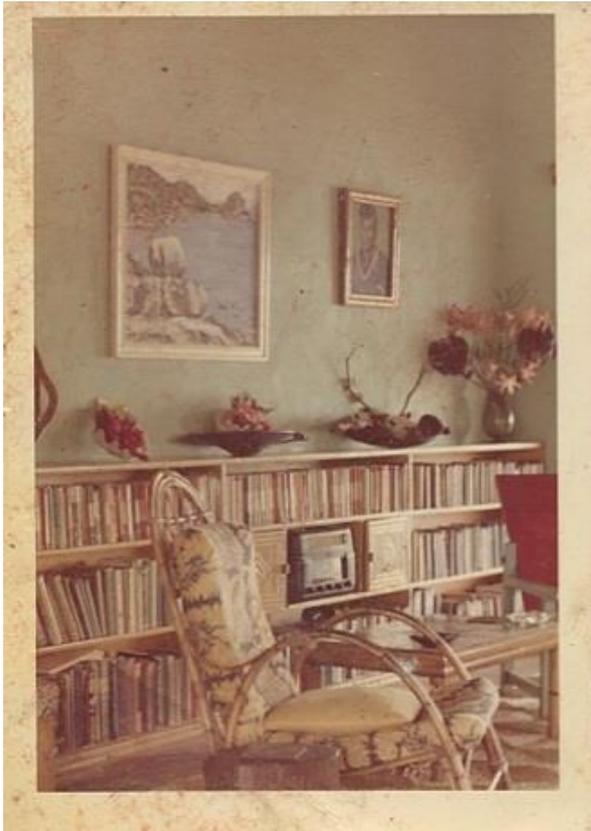
Very early on, prior to wall lights being installed in the Living Room and the verandah being lined with bamboo, there was a pale aqua on the walls which extended along the hall way to the kitchen with remnants behind skirting bamboo at the side hall doorway and in the recessed bamboo shelving in the kitchen. The aqua runs behind the bamboo shelving to the wall in the photo below but the ochre only exists above it. It is proposed that this be used at the kitchen end of the hall on the side where samples were found to keep a record of the colour. In the Living Room, however, a lighter tone of the ochre is recommended to reflect the colour when the house was completed. The Busst bathroom and Laundry and the Kitchen all had a layer of the deep ochre, with matching cabinetry, but an alternative is offered of a more functional off white. Some elements appear to have a very dark stain or paint at the base. Again, a lighter alternative is offered but the darker colour would recreate the original intent.

Figure 4: Living room showing early pale blue limewash (QPWS)

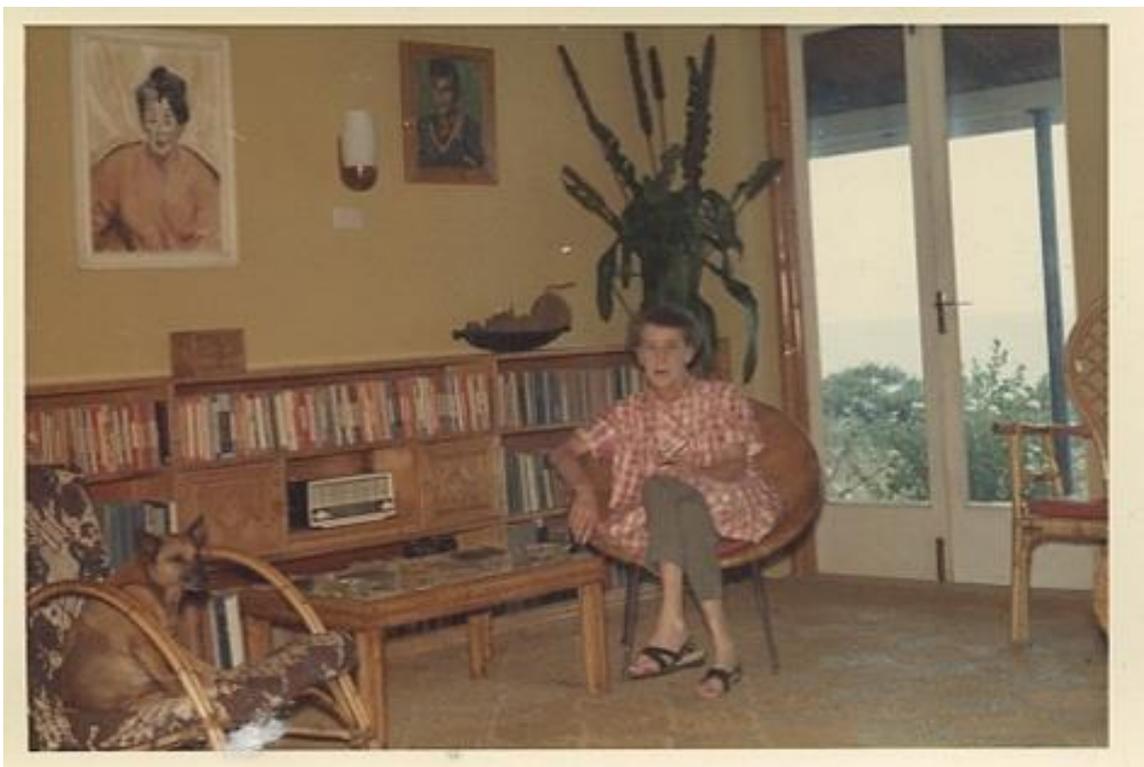
Figure 5: Living Room soon after (bamboo verandah lining not quite complete) with wall light added in a soft ochre/sand colour. This appears much paler than the samples found which may have been affected by subsequent paint layers (VEC)

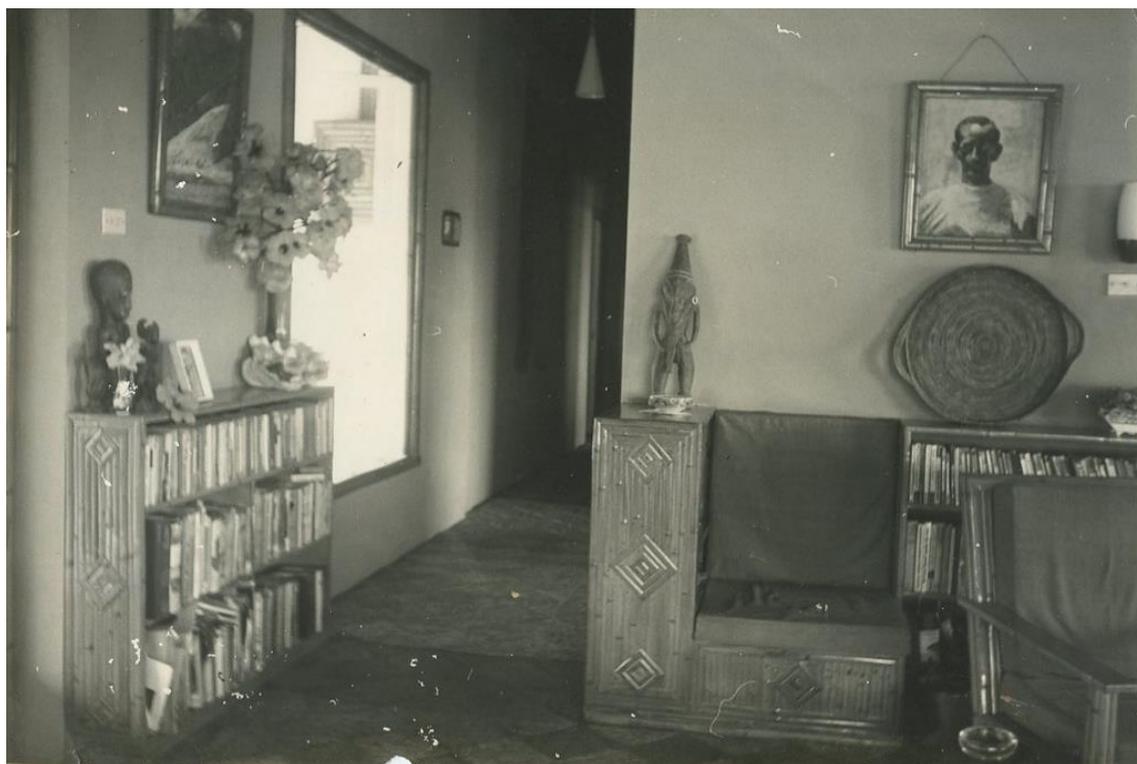
Figure 6: Living Room with view down Hall. Wall light has been added above shelving but bamboo skirtings have not yet been fitted. Flowers and furniture are of soft ochre era (VEC).

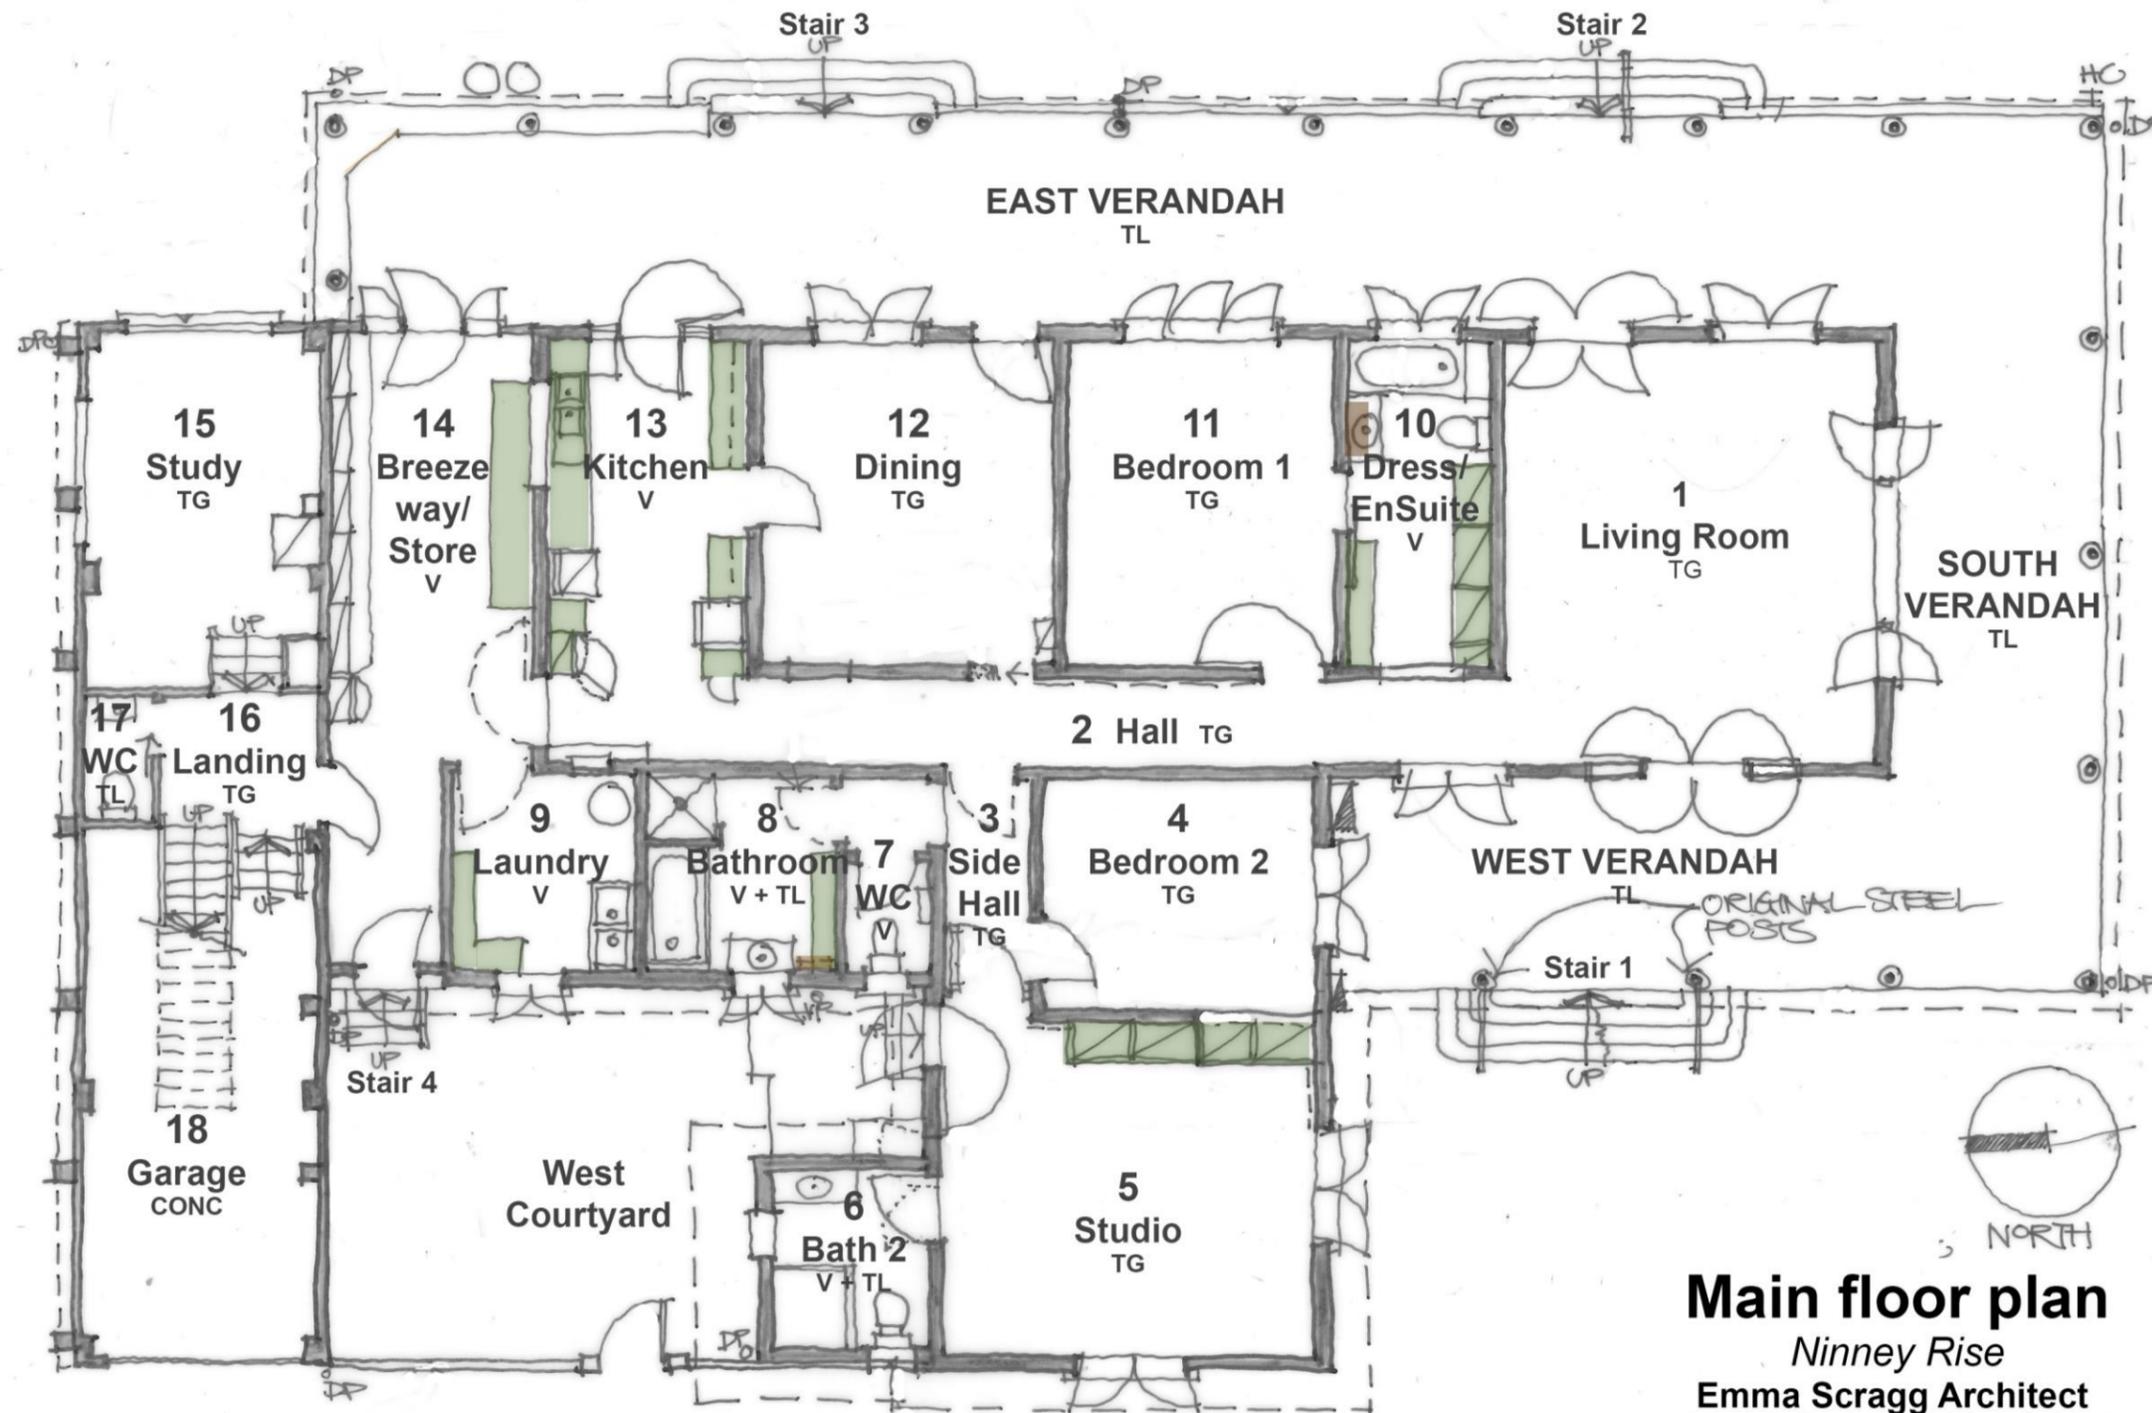
A Key plan

Main floor plan
Ninney Rise
Emma Scragg Architect
based on plans by Michael Gunn Architect
